Department of the Interior
Bureau of Reclamation

OPERATION AND MAINTENANCE EQUIPMENT AND PROCEDURES

RELEASE NO. 29

July, August and September 1959

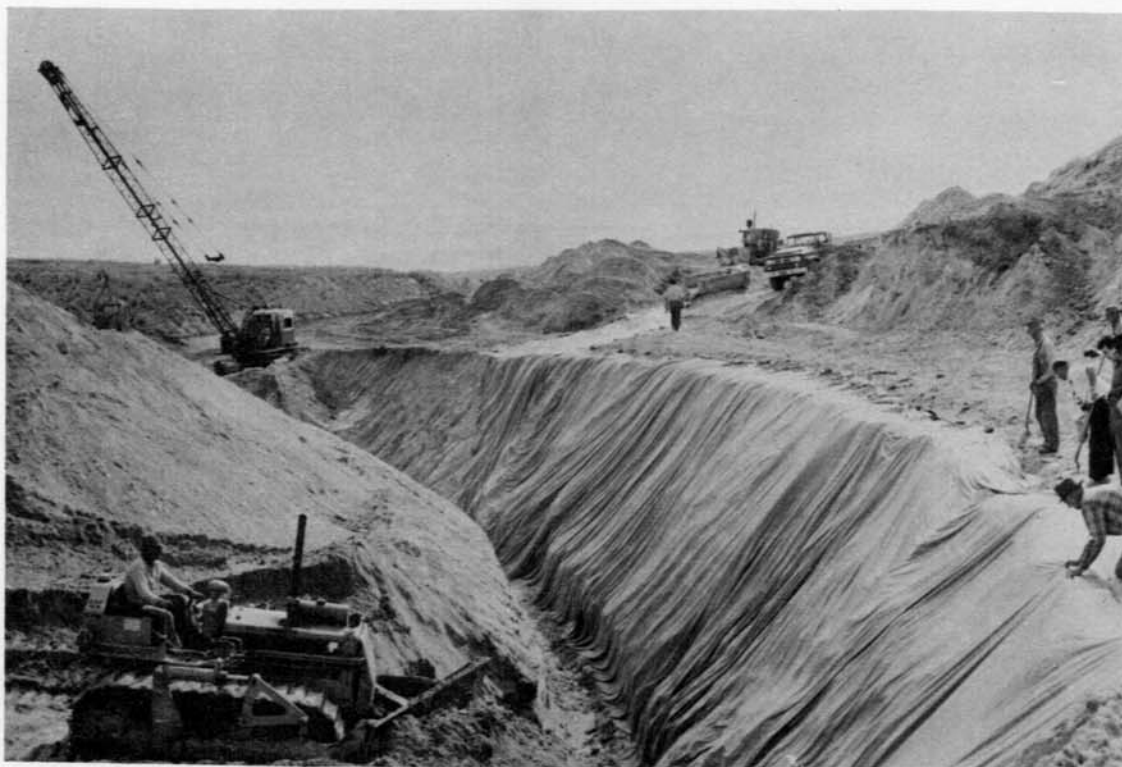
A plastic cutoff curtain is placed in a trench
on the lower bank of a canal on the Boise Proj-
ect, Idaho, to reduce seepage losses. P3-D-16092

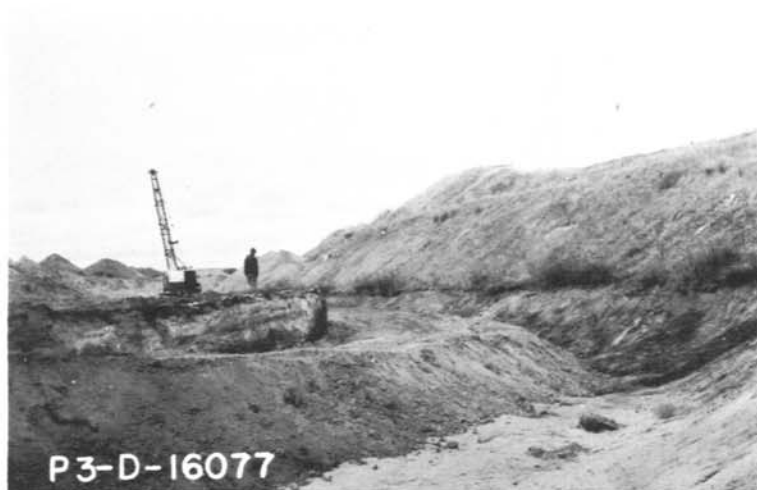
at the site of installation, is located on the side of a low hill, as shown at left, where the subgrade material generally is a sandy loam, but consists in some reaches largely of fine and coarse clean sands overlying a relatively impervious clay layer located approximately 14 feet below the bottom of the canal. High seepage through this section fostered the growth of willows

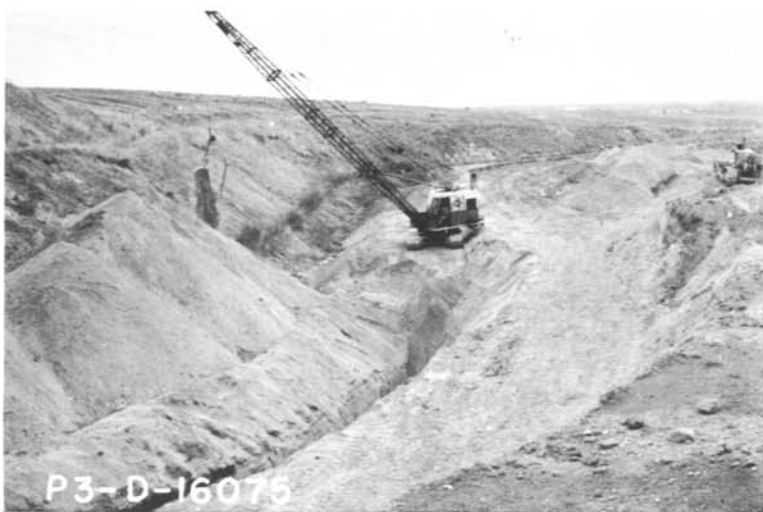
The top of the bench was 18 inches vertically above the operating water level of the canal and was used as the working level for a dragline with a 1-cubic yard bucket, as shown at left. The cutoff trench varied from 26 to 28 feet in depth, with the slope of the upper portion being about $1\frac{1}{2}$:1, while the bottom portion was practically vertical.

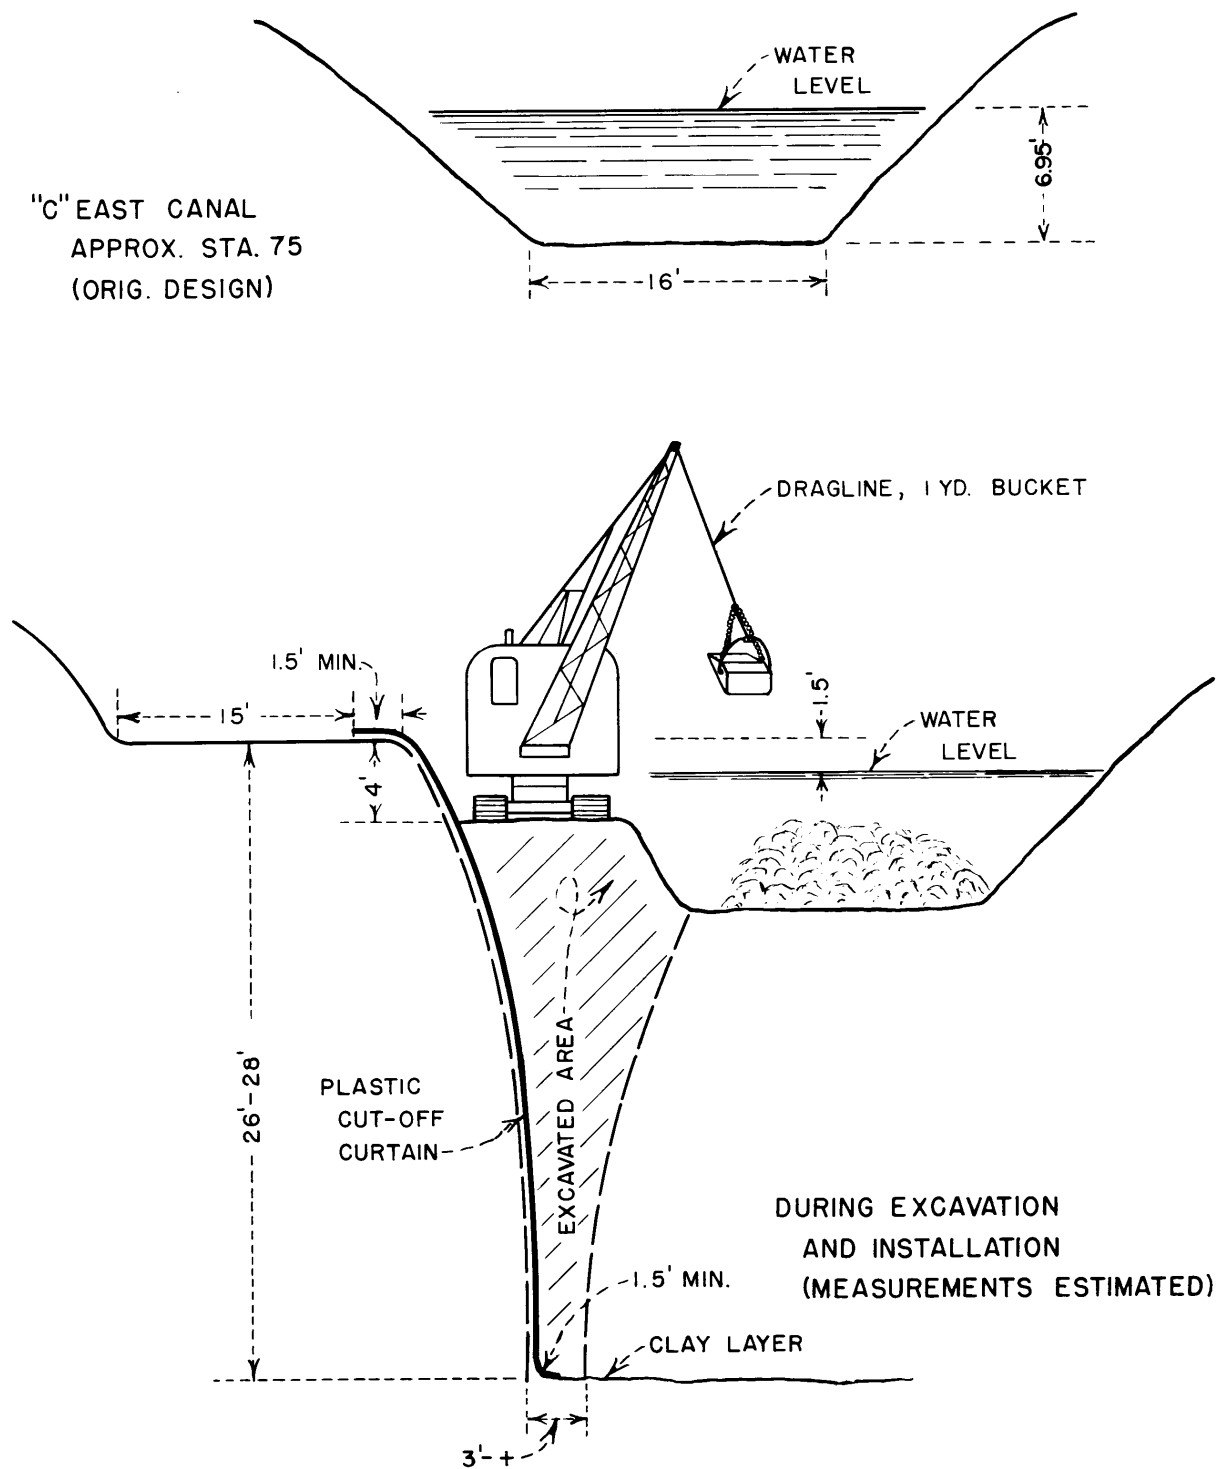
FIGURE 3

"C" EAST CANAL
APPROX. STA. 75
(ORIG. DESIGN)

LOWER COST CANAL LINING PROGRAM (REGION I)
EXPERIMENTAL PLASTIC CUT-OFF CURTAIN INSTALLATION
BLACK CANYON IRRIGATION DISTRICT
NOTUS, IDAHO

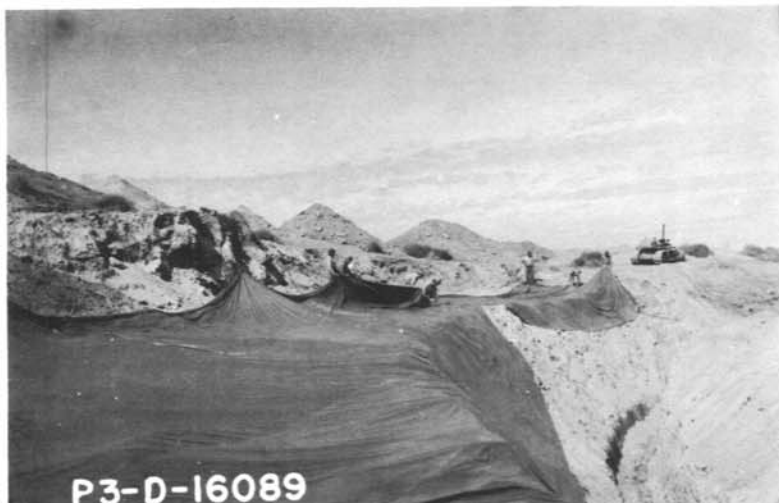
installation and unfold about one-half of the material upstream from that point first; later unfolding the remaining 200 feet in the downstream direction. Accordingly, after about half of the excavation had been completed, the film was spread on the upstream reach, as shown at left, by 8 men in a simple and rapid operation. It was then lowered into the trench gradually, until ap-

proximately $1\frac{1}{2}$ feet of the sheet remained at the bench level. This allowed for ample material in the bottom of the trench on the clay layer.

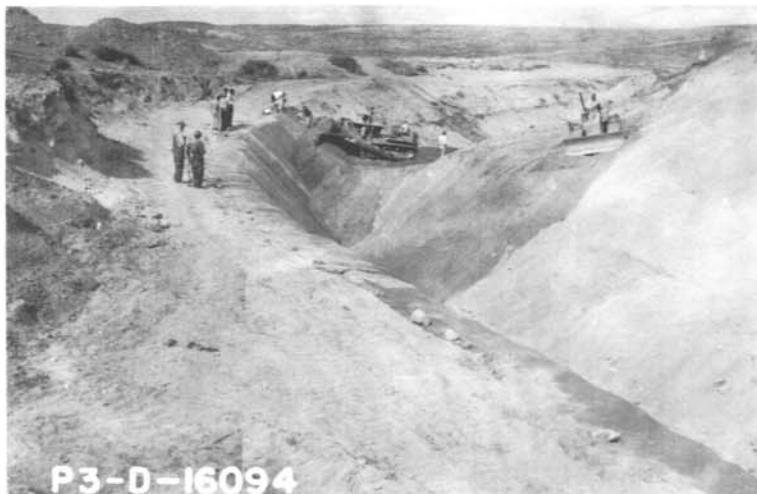
The previously stockpiled material from the trench excavation on the uphill side of the canal was gradually dozed into the trench.

After the trench was completely filled, the cover for the film on the lower bank was worked up the slope, as shown in the upper photograph.

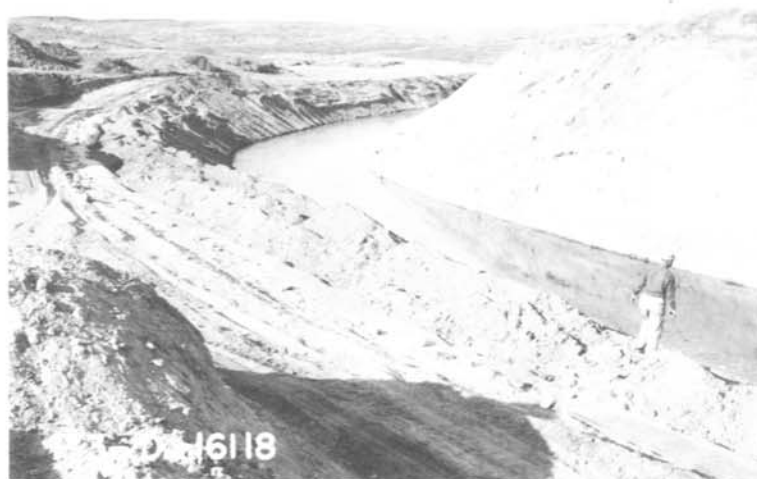
The entire job was accomplished in the period March 30, 1959, when excavation was started, through April 4, 1959, when the canal was placed in operation as shown in the lower photograph. It would seem the plastic has possibilities in emergency repairs

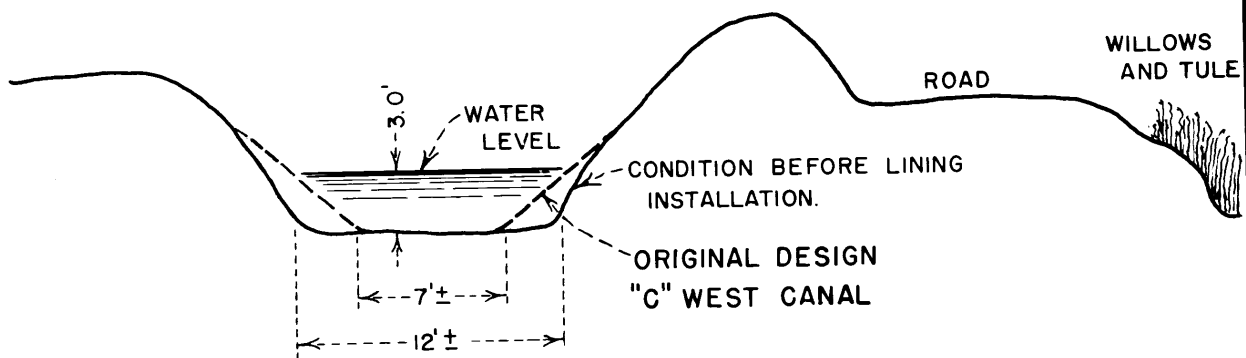
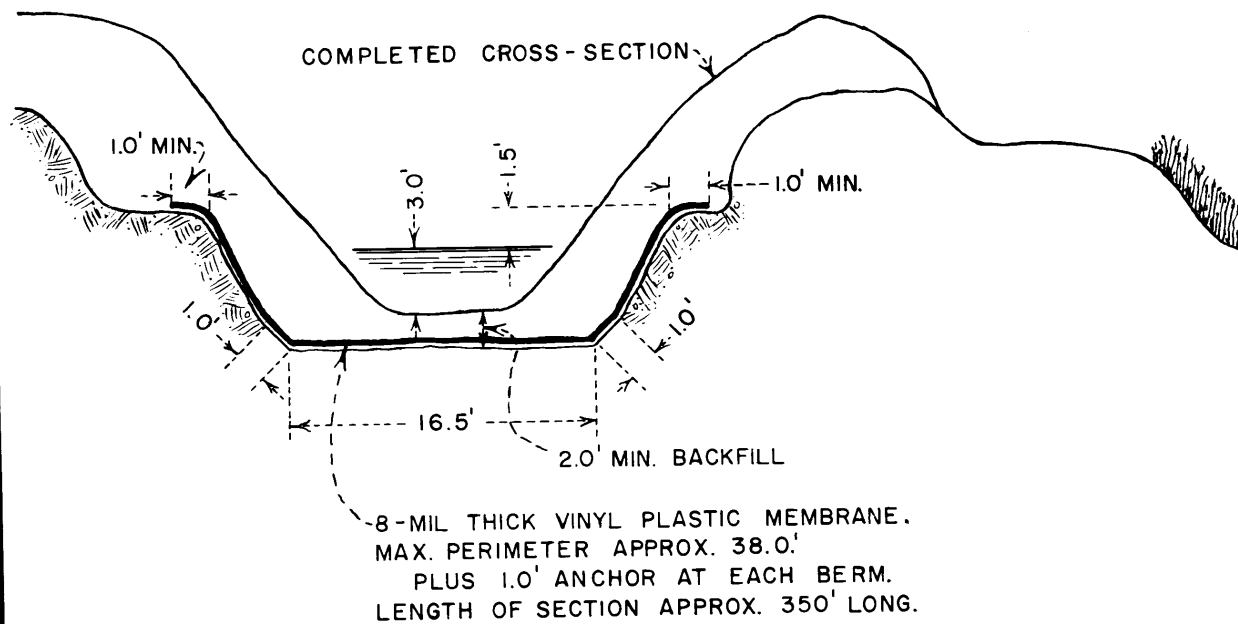
FIGURE 5

LOWER COST CANAL LINING PROGRAM (REGION I)
EXPERIMENTAL BURIED PLASTIC MEMBRANE INSTALLATION
BLACK CANYON IRRIGATION DISTRICT
NOTUS, IDAHO

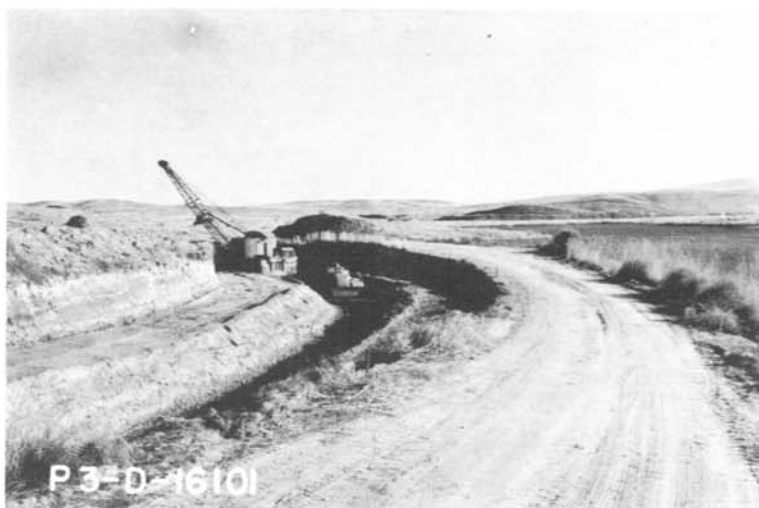
A similar method of benching used in the cutoff curtain installation was employed for the buried lining installation as shown at left. The benches, about 10 feet wide, were leveled by dozers 18 inches in elevation above maximum water elevation in the canal, allowing ample free-board. A dragline excavated the invert 2 feet below normal canal grade.

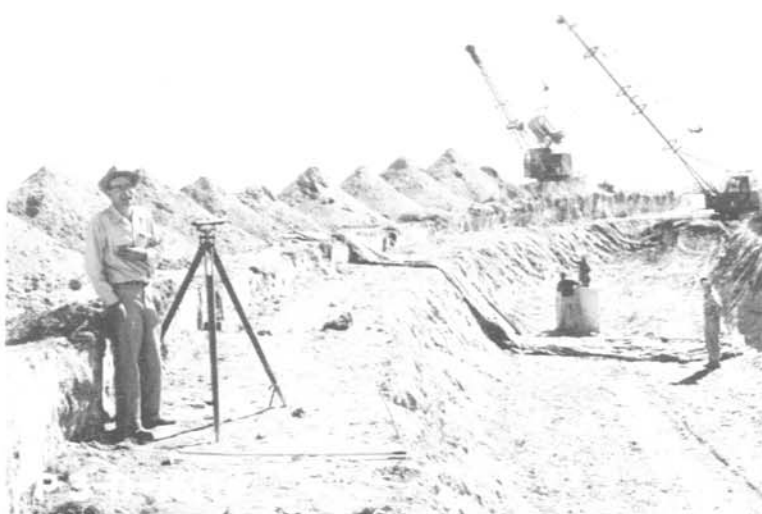
The plastic film, after removal from the shipping crate, was placed near the center of the reach to be lined and methods similar to that used in placing and handling the film for the cutoff curtain were followed. Since the installation was in a curved reach of the canal, some folding of the film was necessary on the inside of the curve.

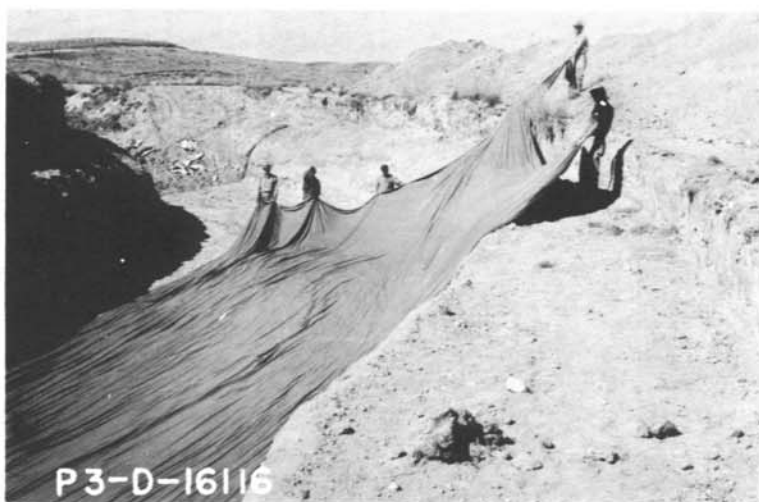
The lining material was placed rapidly and without difficulty, as shown below, with the air temperature at 34 to 35 degrees F. and with the wind velocity up to 15 miles per hour.

It should be pointed out, as will be evident from the photographs, that the side slopes as excavated for the lining were approximately $1\frac{1}{2}:1$ in lieu of the $2\frac{1}{2}:1$ slopes used in previous installations of this kind. This was done purposely to reduce the amount of excavation necessary on the hillside location. One obvious advantage of placing the material over steeper side slopes is that the plastic membrane is buried far deeper at the toe of the slope than in the usual buried membrane installation, and therefore, less likely to become damaged during future cleaning operations with necessary heavy cleaning equipment.

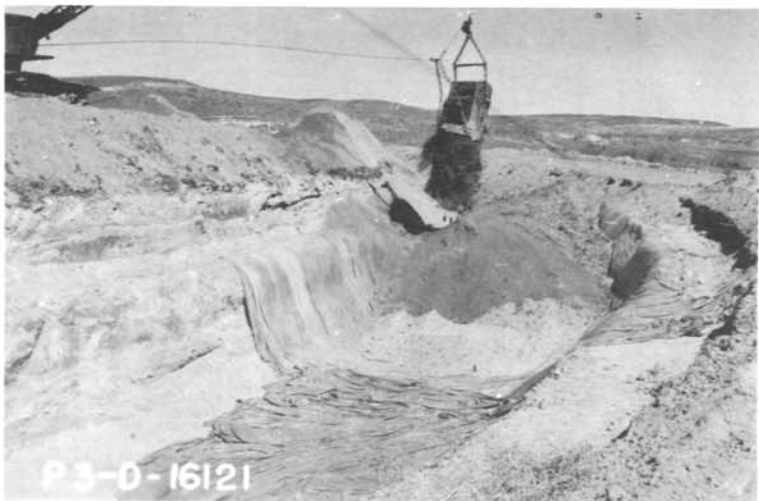
Material excavated from the canal was used to cover the plastic membrane. Placement of the cover was accomplished by both drag-

line and dozer. In the lower photograph the cover material is being deposited on the membrane in the bottom of the canal. The cover on the bottom was spread to a minimum thickness of 2 feet. Side slopes were then replaced to the original $1\frac{1}{2}:1$, as shown in the photograph on the following page.

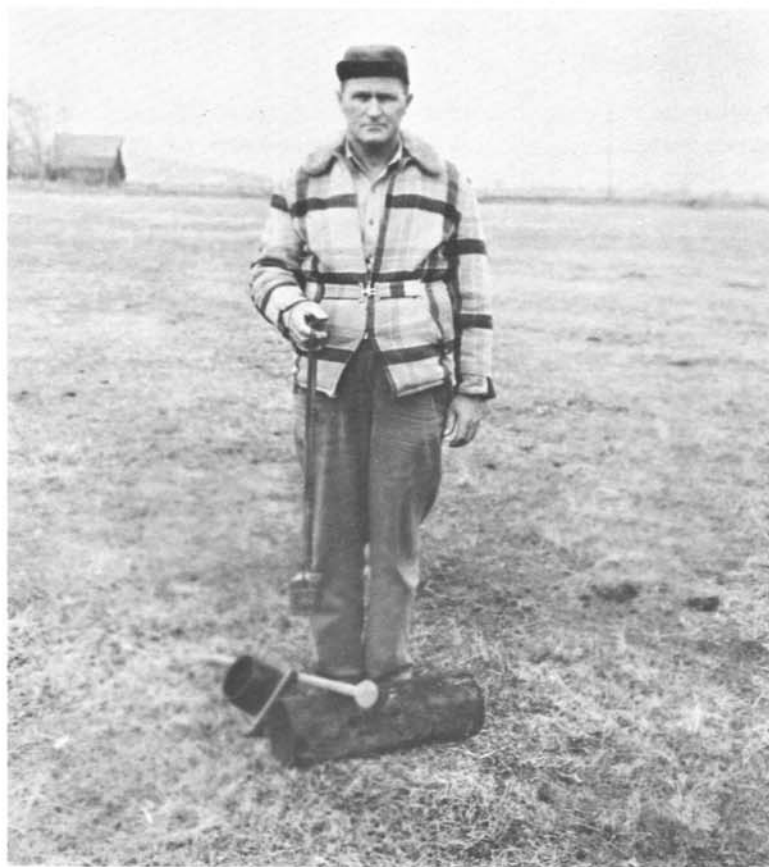
The pipe, pipe cap and the bench-mark type monument are shown in the photograph above.

Mr. Mitchell holds an aquameter, which quickly locates buried markers.

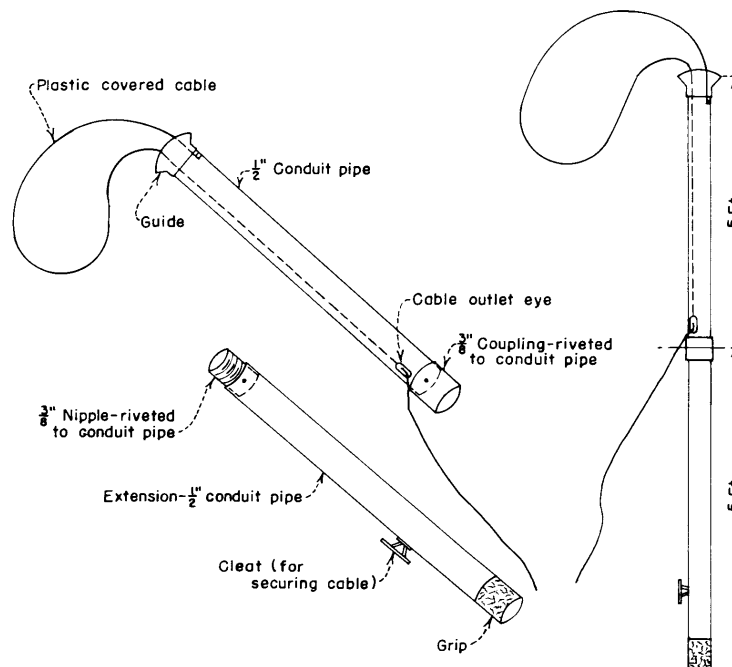
A device for removing dogs or other small animals from canals is shown in the sketch below. The device was the suggestion of Donald J. Berry, Supervisory Engineering Technician, Tracy Operations Field Branch, Central Valley Project, California. The suggestion enables a ditchrider to remove animals from the water without the danger of being bitten.

The device suggested is now in regular use along the Contra Costa Canal System. The two 5-foot sections are threaded together for use, fashioning the loop in the plastic covered cable. In extricating an animal the loop is placed around the animal's midsection and the cable is drawn tight, securing the excess cable to the cleat provided on the handle of the device. Upon removal, the cable can be quickly released.

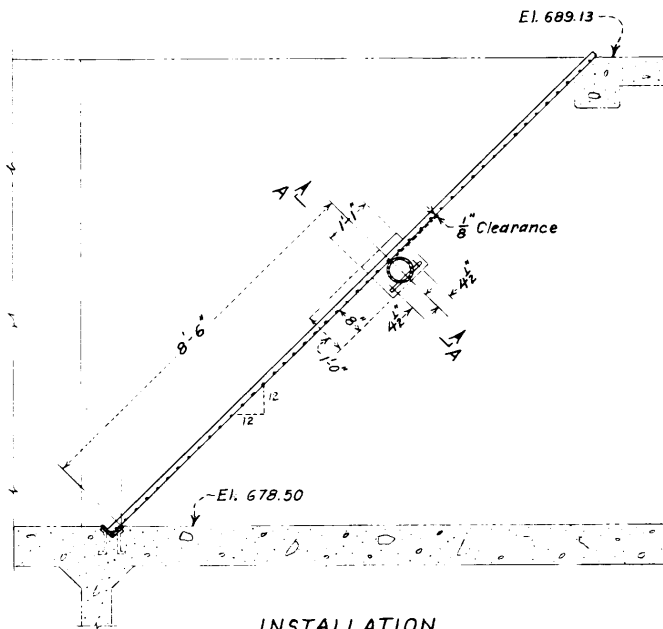
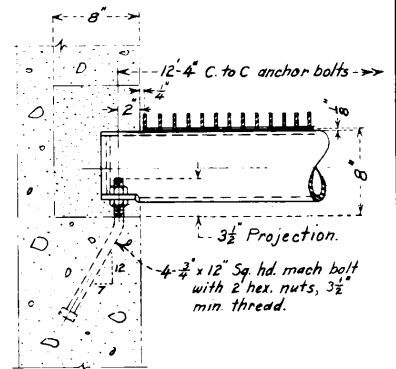
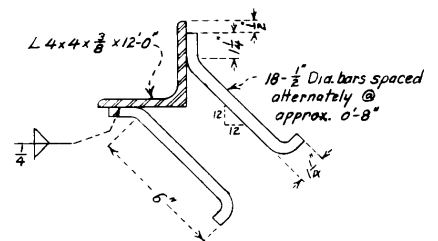
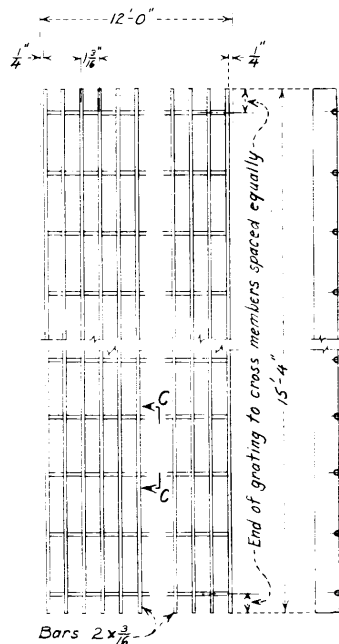
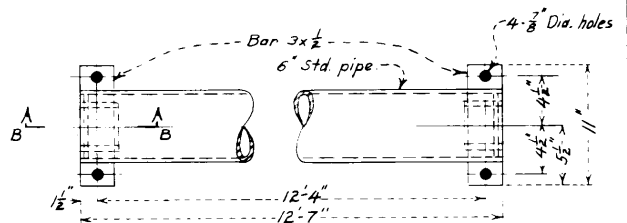
UNITED STATES DEPARTMENT OF THE INTERIOR BUREAU OF RECLAMATION YAKIMA PROJECT KENNEWICK DIVISION-WASHINGTON MAIN CANAL STA. 1301+27.30 TO STA 1322+ 61.31 AMON SIPHON TRASHRACK-SEAT AND SUPPORT	
DRAWN L.L.F.	SUBMITTED C.W. Bennett
TRACED	RECOMMENDED J.S. [Signature]
CHECKED K.V. [Signature]	APPROVED J.S. [Signature]
DENVER, COLORADO	NOV. 16, 1934
566-D-718

The most troublesome spot to which Mr. Nutley referred was provided with a trashrack as shown on the following page during original

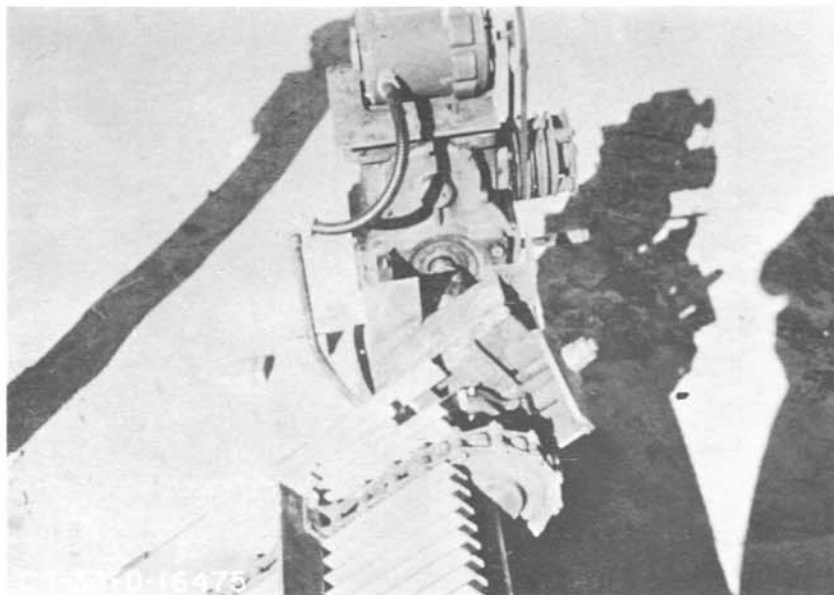
As shown in the photograph above, a 1/4-hp motor provides the power through a stoker gear box and a 1-3/4-inch steel shaft at the top of the rack. The upper bearings are connected to the frame in such a manner that they are adjustable to allow taking slack out of the chain.

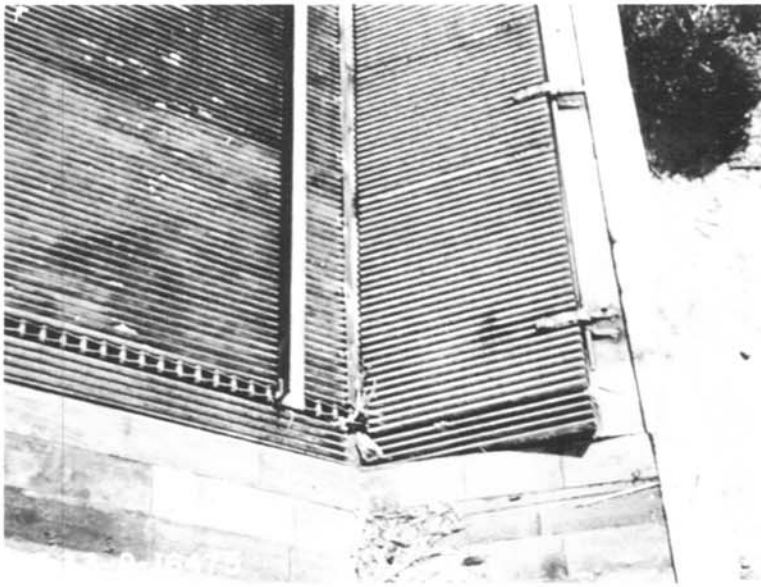
The lower sprockets are attached to the frame through hardwood bearings. These are highly recommended. At the canal bottom, a two-foot flap gate, shown at left, allows for passage of the cleaning angles. Prior to the installation of the device, the trashrack was remodeled so that the rack and cleaning device frame now rests on a $1\frac{1}{2}$:1 slope.

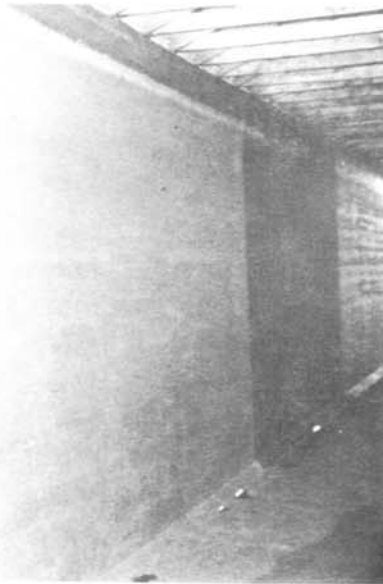
Covering the flumes with a shed roof definitely has advantages. The antifouling paint in the shade of the roof, as shown at left, is in much better condition than that exposed to the direct sunlight as shown in the photograph on the preceding page. An estimate of the annual cost of maintenance with the shed roof is close to that for more frequent painting.

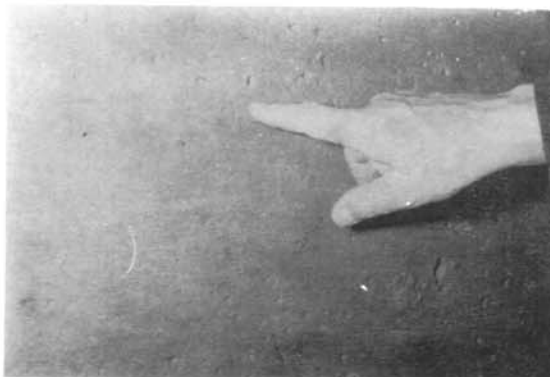
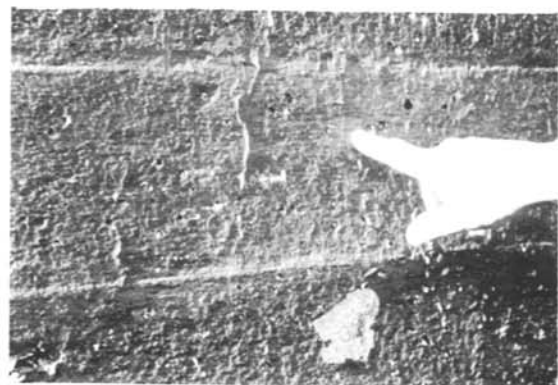
In the photographs above, the condition of the paint with and without the protection of the shed are illustrated. The smooth, adhering paint under the shed in the left photograph, that has been in service two irrigation seasons, is in sharp contrast to the scaling, peeling

and deteriorating surface shown at right that has been in service for a similar length of time, but exposed to the sunlight.

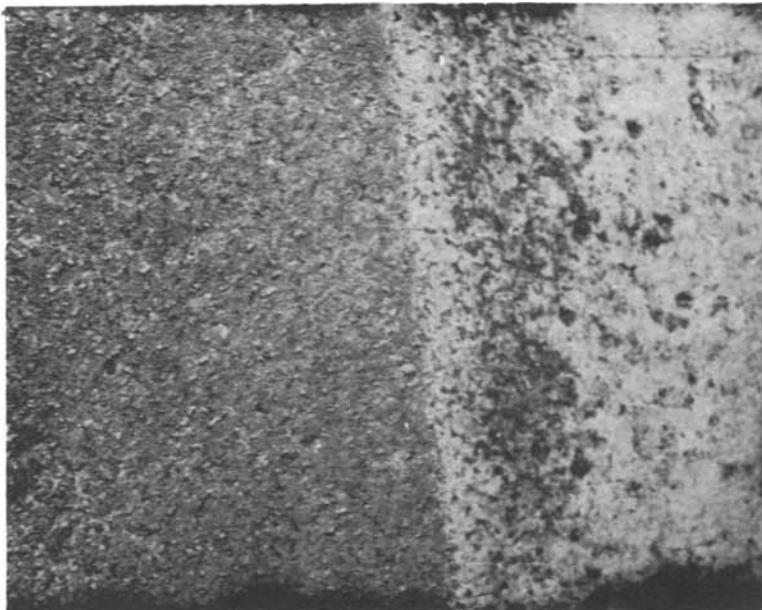
The photograph at left shows the black-fly cocoons adhering to the concrete at the inlet to a siphon, although the concrete surfaces were treated with the antifouling paint.

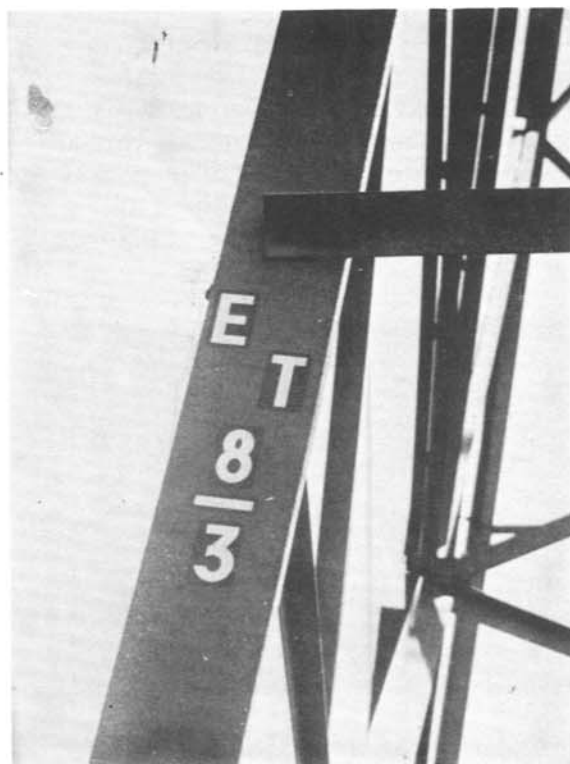
As a result of a suggestion of Electrical Engineer William Eckhoff, that aluminum decals be used in the marking of transmission line towers, automotive equipment and other property, the Bureau's Regional Office in Sacramento, California, decided to try the idea for a year in the marking of identification letters and numbers on transmission line towers, as shown at left.

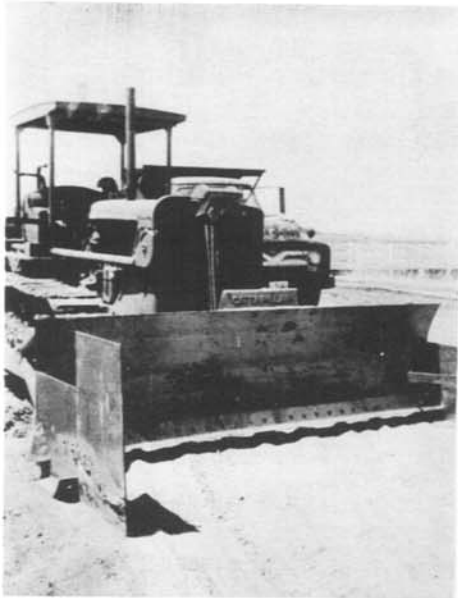
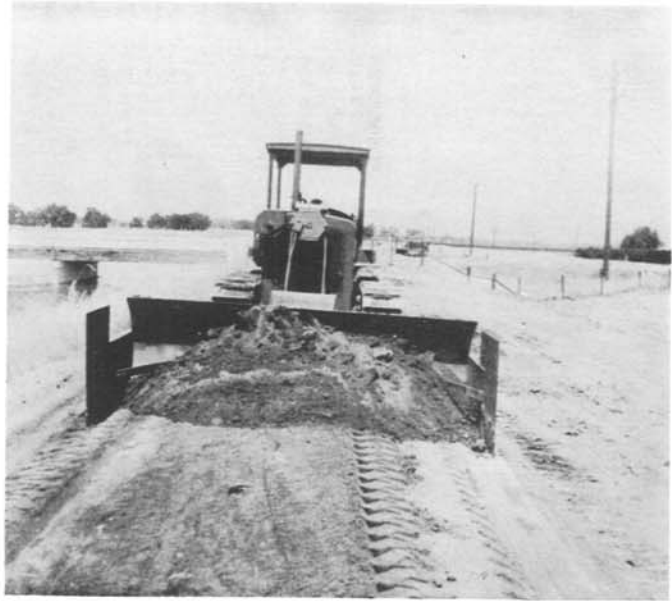
With reference to the above photographs, the side panel of the spreader box was constructed of 3/8-inch plate steel about 24 by 30 inches in size and further cut to fit and welded to the dozer blade with a spread width of 10 feet. The side panels were later lengthened to about 4 feet to better carry the material in the spreading operation. (The top of the side panels had not been cut off at the time the photograph was taken.) The panels were braced with 3/8-inch by 2-inch strap iron, extending from the midpoint of the panel to the dozer blade.

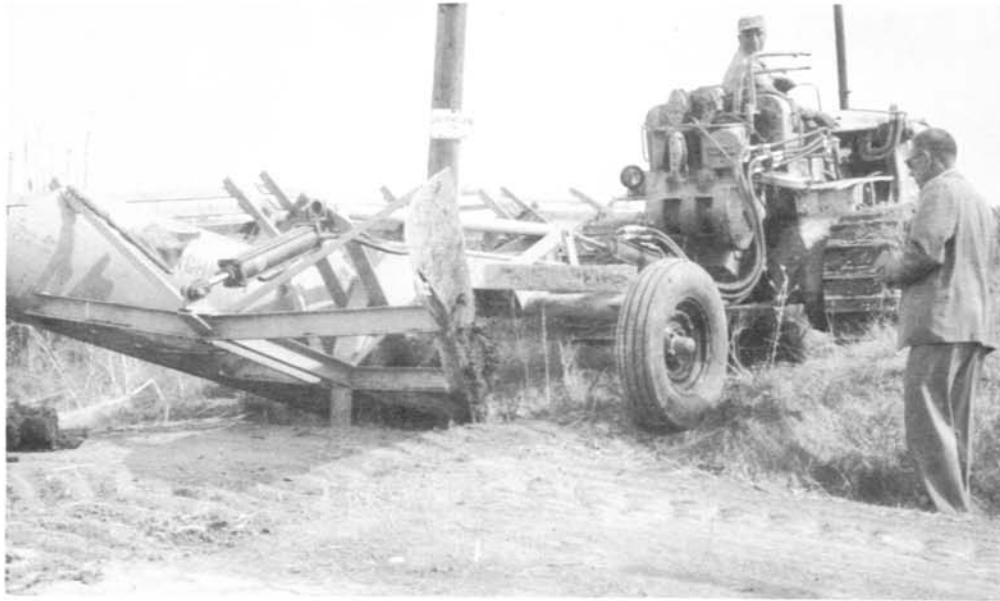
Mr. Axel Persson, retired manager, Lower Yellowstone Project, Sidney, Montana, states that one big advantage of the ditcher shown below and on the following page is that it is coupled directly to the power unit and hydraulically operated, making the work accomplished with the ditcher a one man operation.

The ditcher has two hydraulic controls; one on the plow and one on the traveling gear. The dimensions of the ditcher are: 10.6-foot blade, 10-foot wing spread, and 30-inch depth of blade. The ditcher can be adjusted to clean any size ditch from 1 foot to 4 feet in depth, and can be raised to clear the average structure or ditch bank that the power unit can clear. The ditcher shown in this article and in use on the Lower Yellowstone Project, is mounted on a crawler tractor. With the quick break-away hose connections and hitch, the ditching unit can be dismantled in two minutes.

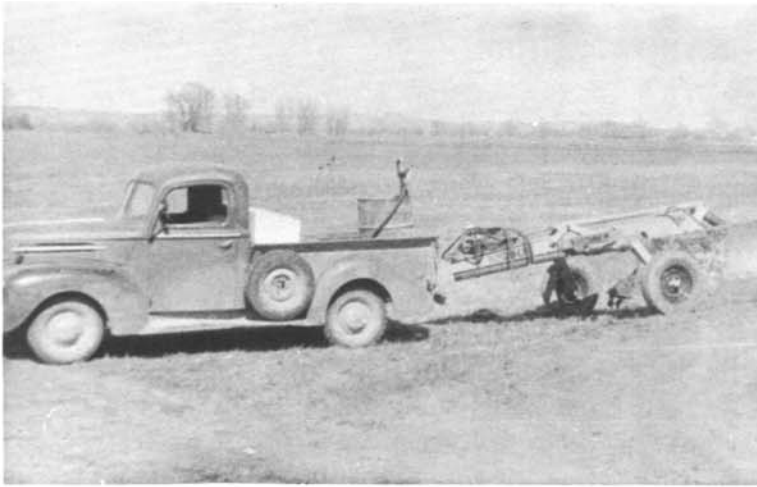
The mobility of the ditcher is shown in the photograph at left. Attached to the pick-up truck, it can be moved from place to place quickly and with a minimum of effort or lost time.

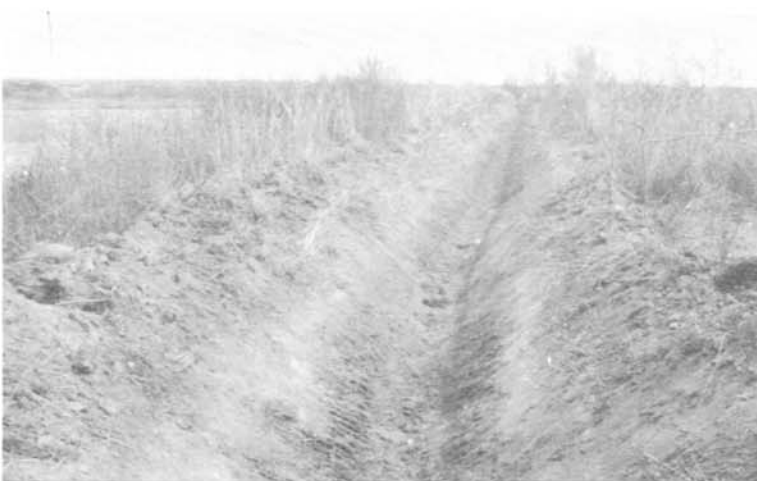
An example of the clean job performed by the piece of equipment is shown in the two lower photographs on this page.

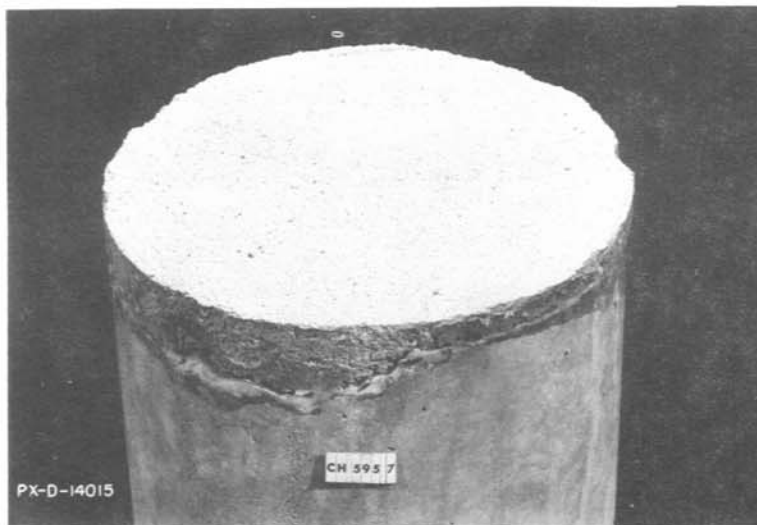
Two types of specimens were used in the tests, as shown at left, 6- by 12-inch cylinders and 3- by 3- by 1-1/2-inch mortar blocks. One half of the top surface of each cylinder was chipped; the other half was left as formed. The surfaces to be patched (capped) on all specimens were then etched with a 5 percent hydrochloric acid solution and rinsed.

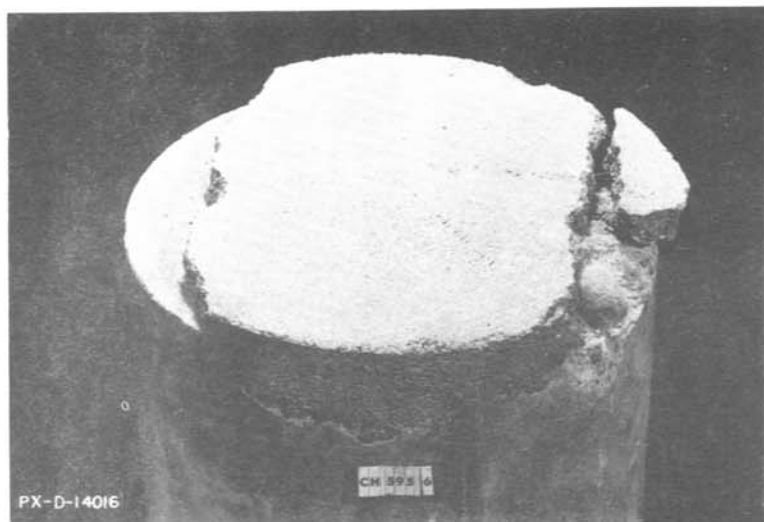
The control or blank specimen, fabricated by applying mortar directly to the surface to be patched without a bonding agent, as stated previously is shown at left. A segment of the patch was broken and disbonded upon each impact of the steel ball on the cylinder patch. The patch to the cylinder after the epoxy-polysulfide bonding agent had been applied as a brush coat to the surface is shown in the upper photograph on

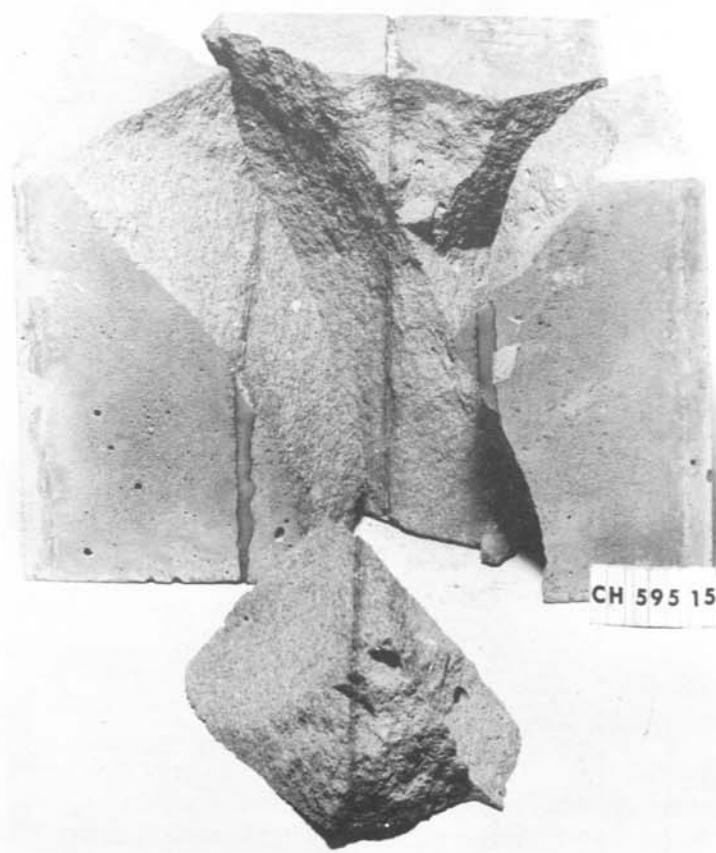
To obtain some idea on how the epoxy-polysulfide would perform as a bonding agent between old concrete and old concrete, two 3- by 3- by 1-1/2-inch blocks were cemented together, cured, and then tested under impact. The surfaces of the two blocks were cleaned, etched, rinsed, and then dried. The bonding agent was brush-applied lightly to each of the surfaces to be joined, again following recommended procedures. The blocks were then placed together and left at room temperature to cure. No pressure was applied to the joint during curing. After 6 days, the impact test was made, with the point of impact being on the joint.

The photograph above shows the result of three impact blows on the joint. No loss of adhesion is evident. The break in the specimen is as if a single solid block were broken.

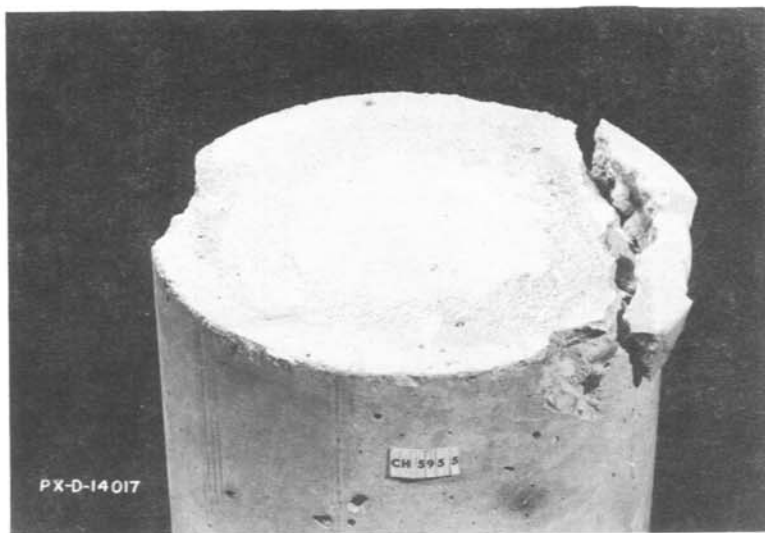
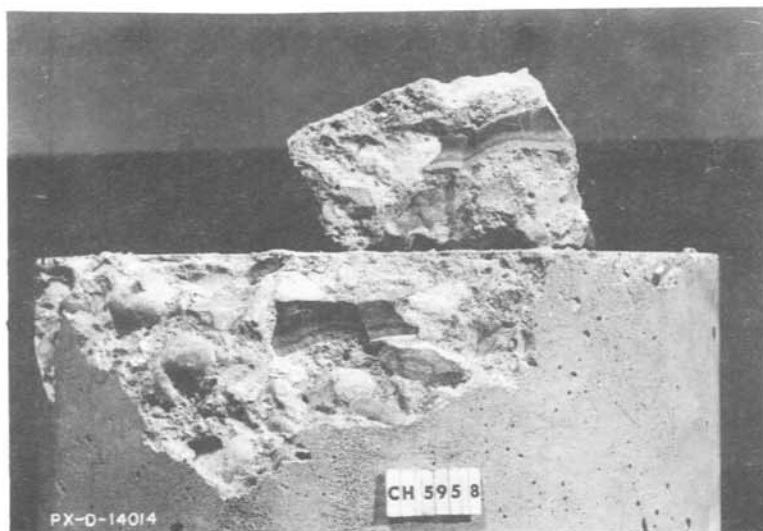
Results of the impact tests are shown in the photographs at left. No apparent damage is evident in the center patch. The concrete base of the edge patch broke rather than the patch after three impact blows. At the left edge is a break in the concrete edge caused by one impact blow on the original concrete to the specimen. Regular impacts on these materials will be made on specimens similar to the mortar patches, rather than on a restrained patch.

The lower photograph shows the broken concrete base of the edge patch shown in the upper photograph at the right side.

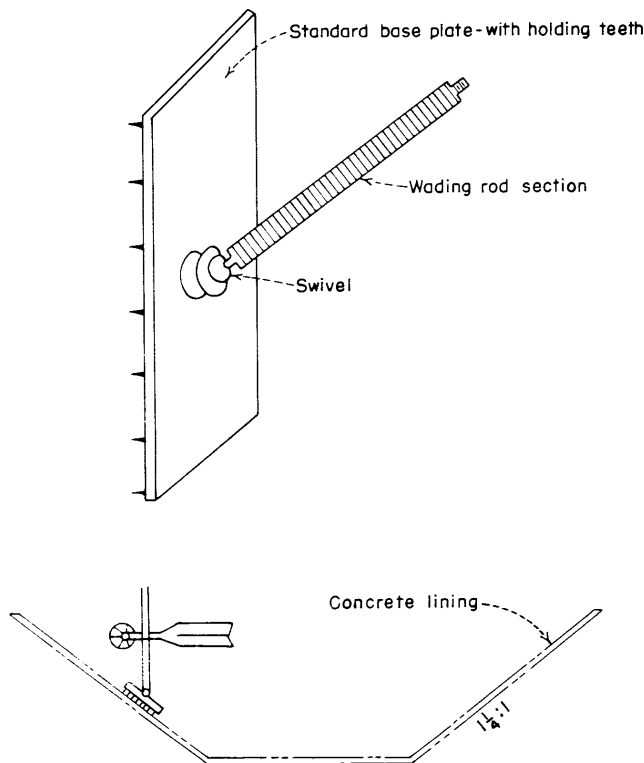
The device consists of case hardened steel teeth on the bottom of a metal base plate as shown in the sketch above and aids materially in holding the rod steady on the sloping concrete. A swivel permits positioning of the wading rod and current meter in a vertical position. Holding the meter properly allows the hub bearing to turn freely on the pin.

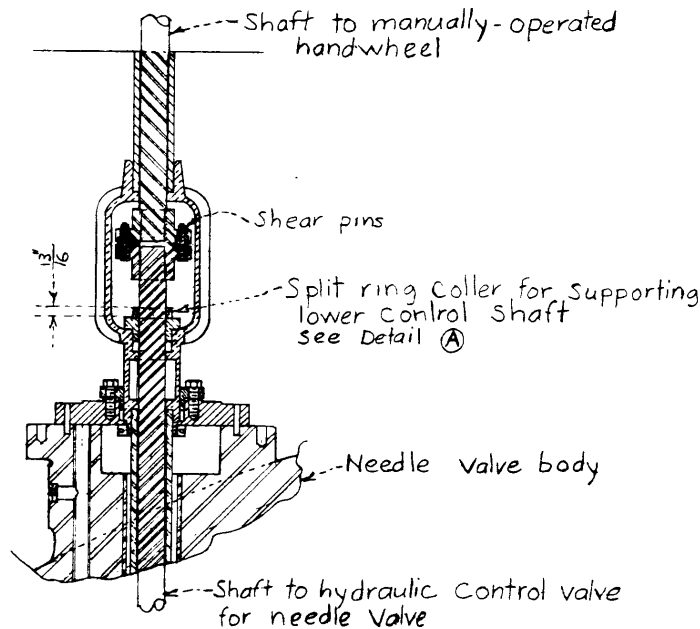
HOOVER DAM
SUPPORT FOR CONTROL SHAFT
ON NEEDLE VALVES

The bearing that supports the lower section of the control shaft is inside the 4-way control valve. Consequently, this section of the control shaft must be supported from above before the control valve can be dismantled. Because of the corrosive action of the Colorado River Water, the piston-type valves must be dismantled and cleaned annually. Cleaning operations include removing the loose rust and scale

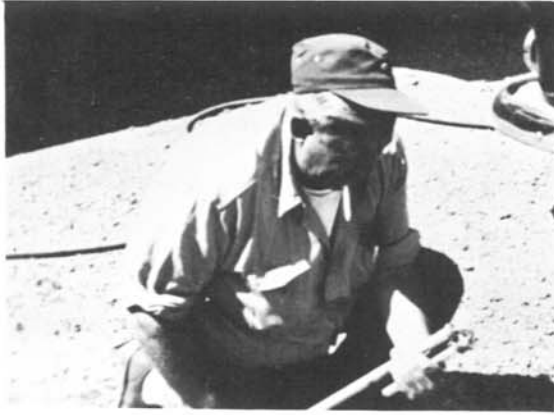
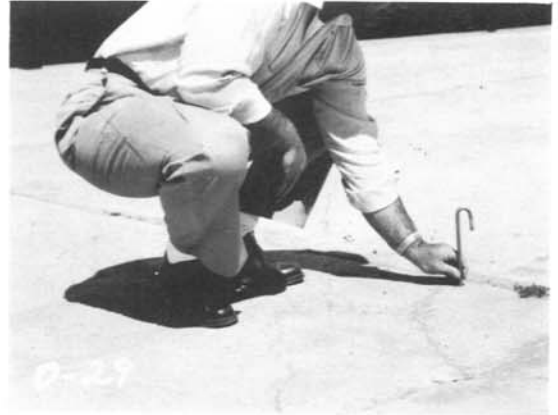
with a bolt cutter, the spikes can be used instead of eye bolts, at a cost of only about 4 cents each, which includes the cost of labor for bending and cutting. The jig for bending the spikes and one of the finished spikes are shown in the photographs below.
